**BRENTFORD
COMMUNITY STADIUM**
More than just a football club

Stadium & Related Infrastructure

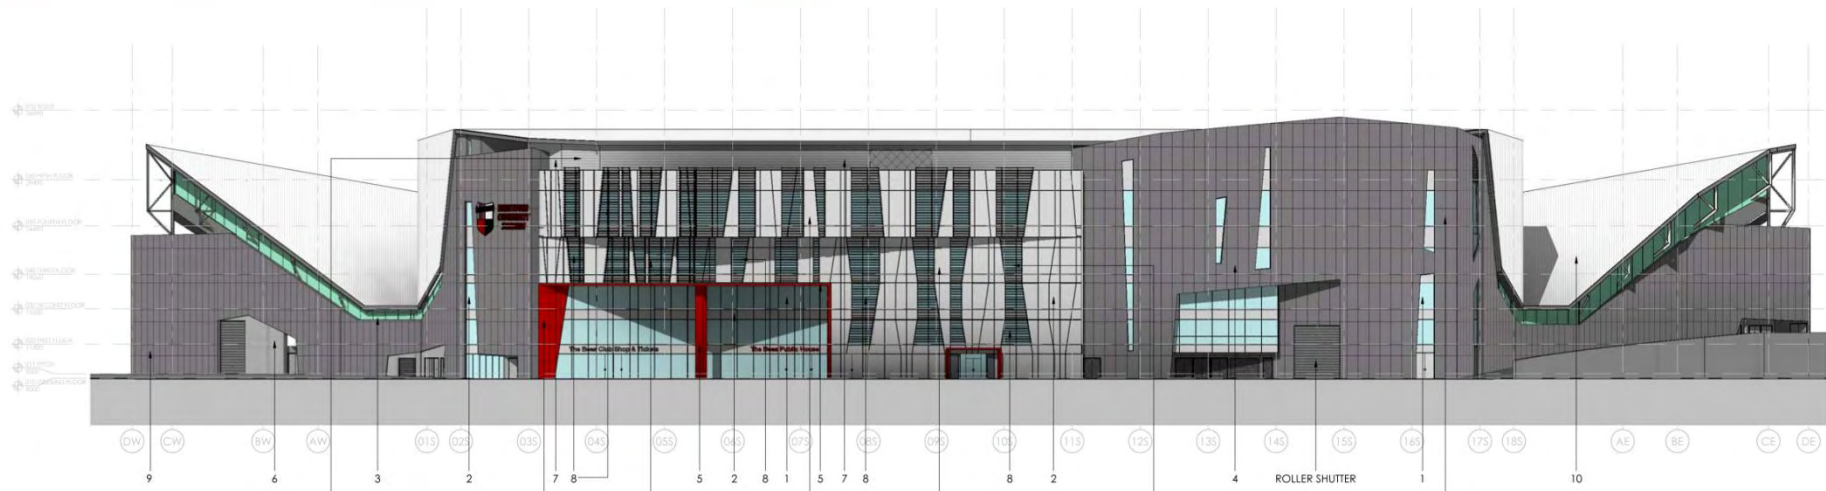
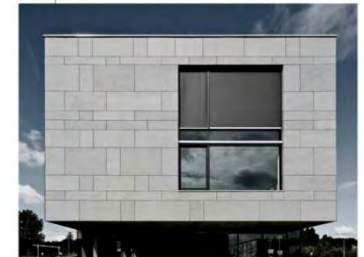
1 SOUTH ELEVATION 1 : 250

1	TRANSPARENT DOUBLE GLAZED UNITS WITHIN A CURTAIN WALLING SYSTEM SUCH AS SCHUCO FW50+	4	RAINSREEN CLADDING SYSTEM SUCH AS MARLEY ETERNIT EQUITONE NATURA	7	LOUVRE LOOK METAL CLADDING PANELS SUCH AS ARCHITECTURAL PROFILES LOUVRE WALL PROFILE	10	ALUMINIUM STANDING SEAM SINGLE SKIN ROOF SYSTEM FIXED TO STRUCTURAL STEELWORK SUCH AS KALZIP, PROFILED PPC FASCIA PANELS TO LEADING EDGE OF ALL ROOFS, FRONT AND BACK
2	BACK PAINTED DOUBLE GLAZED SPANDREL GLASS UNITS WITHIN A CURTAIN WALLING SYSTEM SUCH AS SCHUCO FW50+	5	TRESPA METEON RAINSCREEN CLADDING IN RED; ALSO USED ON SOFFIT	8	ALUMINIUM BRIS SOLEIL SOLAR SHADING SYSTEM TO SOUTH FACADE SUCH AS SCHUCO LARGE LOUVRE BLADES		
3	POLYCARBONATE CLADDING SUCH RODECA ON PROPRIETARY FRAMING SYSTEM	6	CONCRETE BLOCKWORK	9	PAINTED TIMBER HOARDING TO FIT OUT AREAS

CURTAIN WALLING SUCH AS SCHUCO FW50+ WITH EXPRESSED VERTICAL MULLIONS

SPANDREL CURTAIN WALLING PANEL WITH EXPRESSED VERTICAL MULLIONS

ROLLER SHUTTER

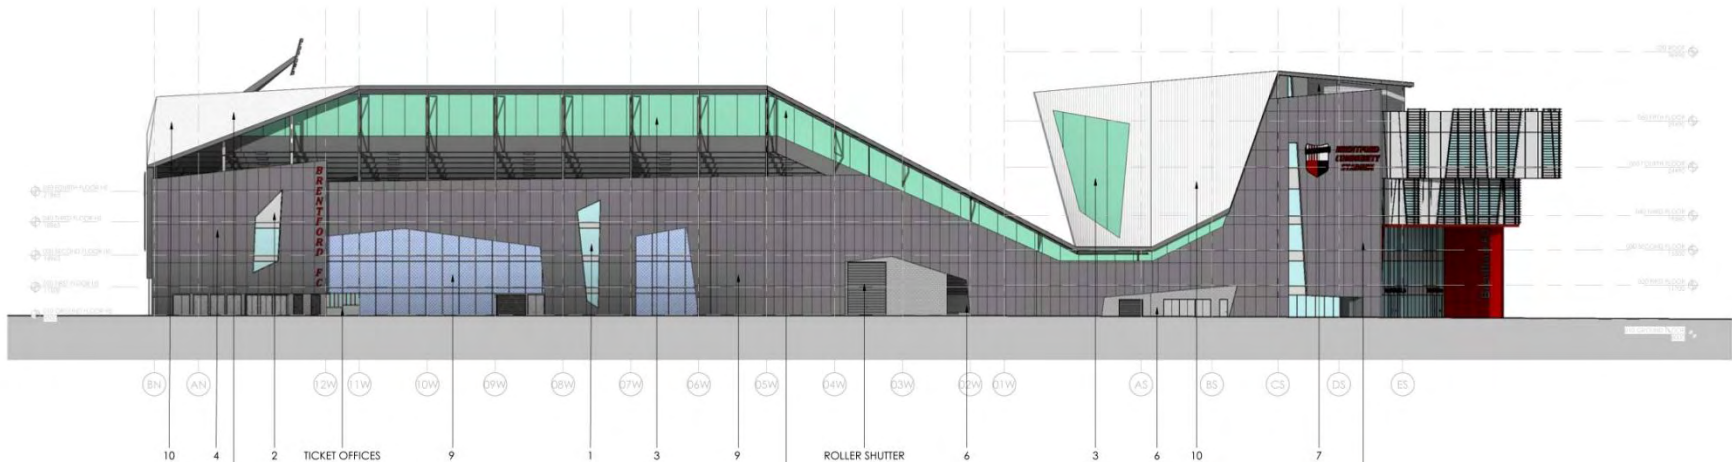
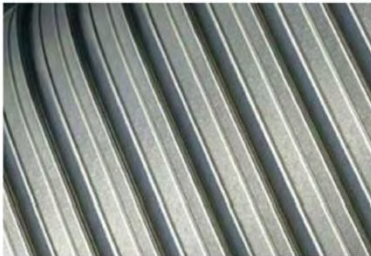
1 WEST ELEVATION 1:250

1	TRANSPARENT DOUBLE GLAZED UNITS WITHIN A CURTAIN WALLING SYSTEM SUCH AS SCHUCO FW50+	4	RAINSCREEN CLADDING SYSTEM SUCH AS MARLEY ETERNIT EQUITONE NATURA	7	LOUVRE LOOK METAL CLADDING PANELS SUCH AS ARCHITECTURAL PROFILES LOUVRE WALL PROFILE	10	ALUMINIUM STANDING SEAM SINGLE SKIN ROOF SYSTEM FIXED TO STRUCTURAL STEELWORK SUCH AS KALZIP; PROFILED PPC FASCIA PANELS TO LEADING EDGE OF ALL ROOFS, FRONT AND BACK
2	BACK PAINTED DOUBLE GLAZED SPANDREL GLASS UNITS WITHIN A CURTAIN WALLING SYSTEM SUCH AS SCHUCO FW50+	5	TRESPA METEON RAINSCREEN CLADDING IN RED; ALSO USED ON SOFFIT	8	ALUMINIUM BRIS SOLEIL SOLAR SHADING SYSTEM TO SOUTH FACADE SUCH AS SCHUCO LARGE LOUVRE BLADES		
3	POLYCARBONATE CLADDING SUCH RODECA ON PROPRIETARY FRAMING SYSTEM	6	CONCRETE BLOCKWORK	9	PAINTED TIMBER HOARDING TO FIT OUT AREAS

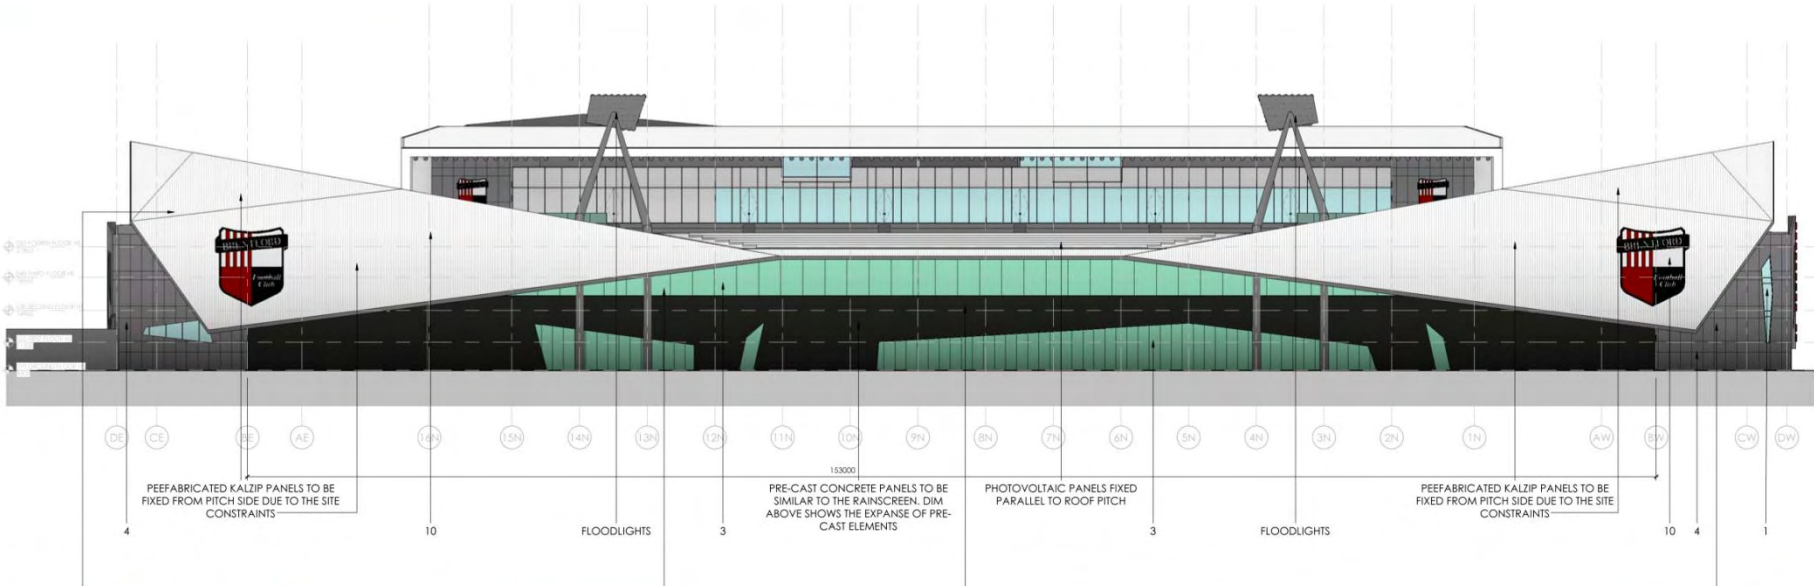
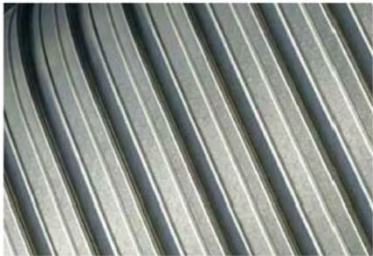
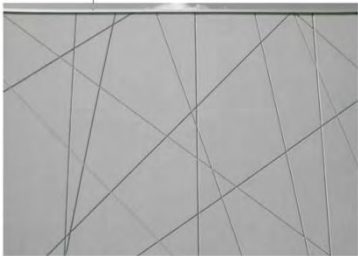
Elevations | North Elevation

1	TRANSPARENT DOUBLE GLAZED UNITS WITHIN A CURTAIN WALLING SYSTEM SUCH AS SCHUCO FW50+	4	RAINSCREEN CLADDING SYSTEM SUCH AS MARLEY ETERNIT EQUITONE NATURA	7	LOUVRE LOOK METAL CLADDING PANELS SUCH AS ARCHITECTURAL PROFILES LOUVRE WALL PROFILE	10	ALUMINIUM STANDING SEAM SINGLE SKIN ROOF SYSTEM FIXED TO STRUCTURAL STEELWORK SUCH AS KALZIP, PROFILED PPC FASCIA PANELS TO LEADING EDGE OF ALL ROOFS, FRONT AND BACK
2	BACK PAINTED DOUBLE GLAZED SPANDREL GLASS UNITS WITHIN A CURTAIN WALLING SYSTEM SUCH AS SCHUCO FW50+	5	TRESPA METEON RAINSCREEN CLADDING IN RED, ALSO USED ON SOFFIT	8	ALUMINIUM BRIS SOLEIL SOLAR SHADING SYSTEM TO SOUTH FACADE SUCH AS SCHUCO LARGE LOUVRE BLADES		
3	POLYCARBONATE CLADDING SUCH RODECA ON PROPRIETARY FRAMING SYSTEM	6	CONCRETE BLOCKWORK	9	PAINTED TIMBER HOARDING TO FIT OUT AREAS

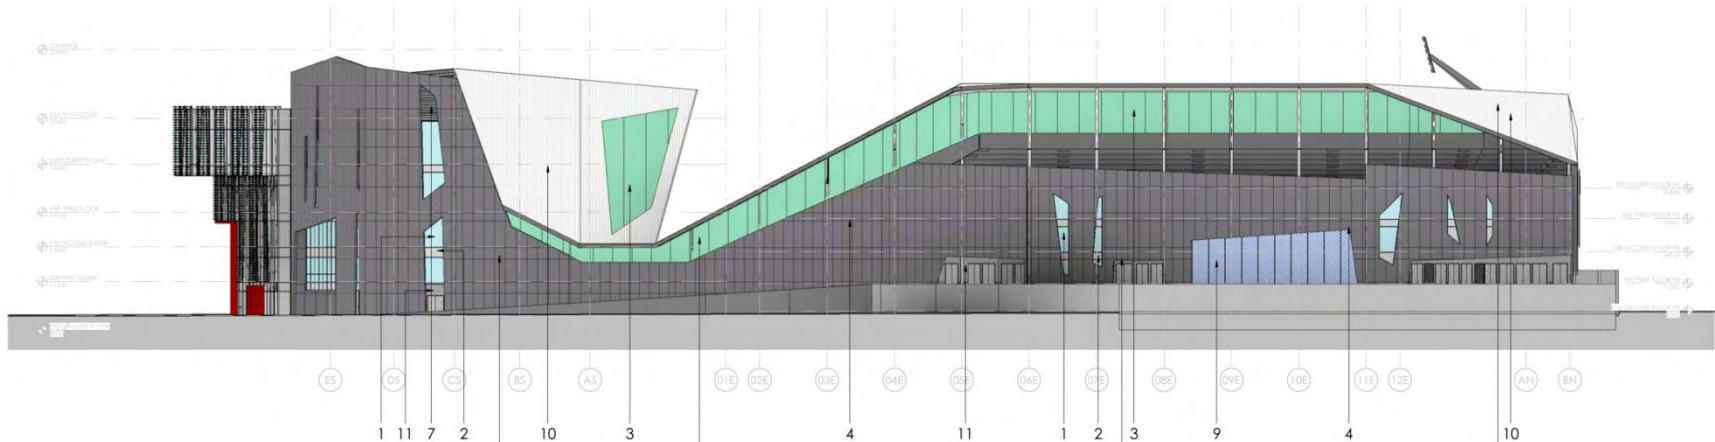
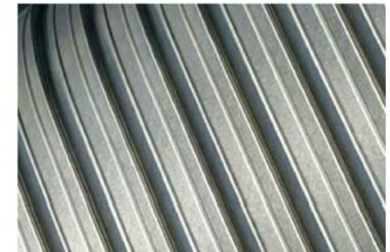
Elevations | East Elevation

1	TRANSPARENT DOUBLE GLAZED UNITS WITHIN A CURTAIN WALLING SYSTEM SUCH AS SCHUCO FW50+	4	RAINSCREEN CLADDING SYSTEM SUCH AS MARLEY ETERNIT EQUITONE NATURA	7	LOUVRE LOOK METAL CLADDING PANELS SUCH AS ARCHITECTURAL PROFILES LOUVRE WALL PROFILE	10	ALUMINIUM STANDING SEAM SINGLE SKIN ROOF SYSTEM FIXED TO STRUCTURAL STEELWORK SUCH AS KALZIP, PROFILED PPC FASCIA PANELS TO LEADING EDGE OF ALL ROOFS, FRONT AND BACK
2	BACK PAINTED DOUBLE GLAZED SPANDREL GLASS UNITS WITHIN A CURTAIN WALLING SYSTEM SUCH AS SCHUCO FW50+	5	TRESPA METEON RAINSCREEN CLADDING IN RED, ALSO USED ON SOFFIT	8	ALUMINIUM BRIS SOLEIL SOLAR SHADING SYSTEM TO SOUTH FACADE SUCH AS SCHUCO LARGE LOUVRE BLADES		
3	POLYCARBONATE CLADDING SUCH RODECA ON PROPRIETARY FRAMING SYSTEM	6	CONCRETE BLOCKWORK	9	PAINTED TIMBER HOARDING TO FIT OUT AREAS

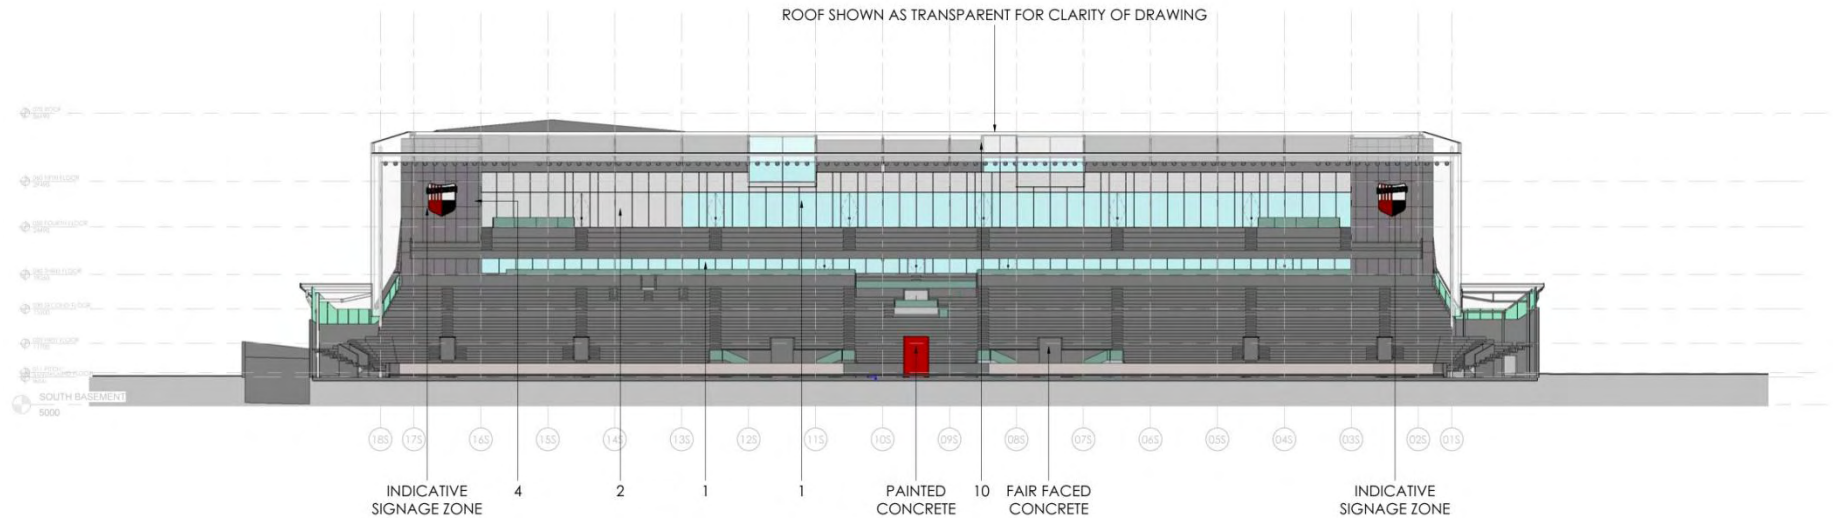
1 PITCHSIDE ELEVATION - SOUTH STAND
1 : 250

1	TRANSPARENT DOUBLE GLAZED UNITS WITHIN A CURTAIN WALLING SYSTEM SUCH AS SCHUCO FW50+	4	RAINSCREEN CLADDING SYSTEM SUCH AS MARLEY ETERNIT EQUITONE NATURA	7	LOUVRE LOOK METAL CLADDING PANELS SUCH AS ARCHITECTURAL PROFILES LOUVRE WALL PROFILE	10	ALUMINIUM STANDING SEAM SINGLE SKIN ROOF SYSTEM FIXED TO STRUCTURAL STEELWORK SUCH AS KALZIP, PROFILED PPC FASCIA PANELS TO LEADING EDGE OF ALL ROOFS, FRONT AND BACK
2	BACK PAINTED DOUBLE GLAZED SPANDREL GLASS UNITS WITHIN A CURTAIN WALLING SYSTEM SUCH AS SCHUCO FW50+	5	TRESPA METEON RAINSCREEN CLADDING IN RED, ALSO USED ON SOFFIT	8	ALUMINIUM BRIS SOLEIL SOLAR SHADING SYSTEM TO SOUTH FACADE SUCH AS SCHUCO LARGE LOUVRE BLADES		
3	POLYCARBONATE CLADDING SUCH RODECA ON PROPRIETARY FRAMING SYSTEM	6	CONCRETE BLOCKWORK	9	PAINTED TIMBER HOARDING TO FIT OUT AREAS
